Manhole Inspection Summary

Manhole # S71Q__009MH

Insp Date: **4/10/08 11:43 AM**

Location Address: **6726 Roberts Ave.**

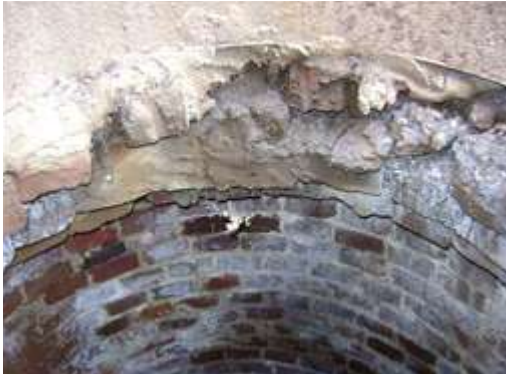
Defect 4

Condition: ☐ Sound ☐ Cracked ☐ Root Intrusion ☒ **Loose Brick** ☒ **Deteriorated**

Infiltration: ☐ None ☒ **Joint** ☐ Cracks ☐ Mortar ☐ Roots ☐ Wall

Loose and missing bricks from chimney. Heavy deterioration. Joint and mortar infiltration.

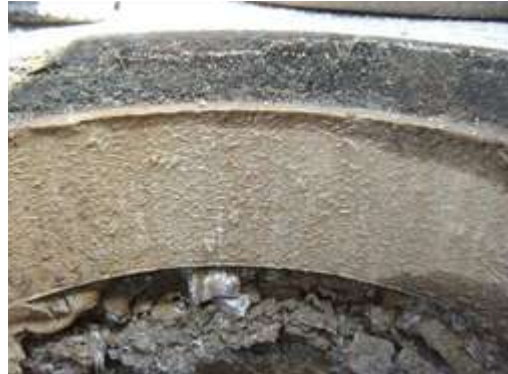
Defect 3

Condition: ☐ Sound ☒ **Cracked** ☐ Leaks

Deterioration under frame. Infiltration evident.

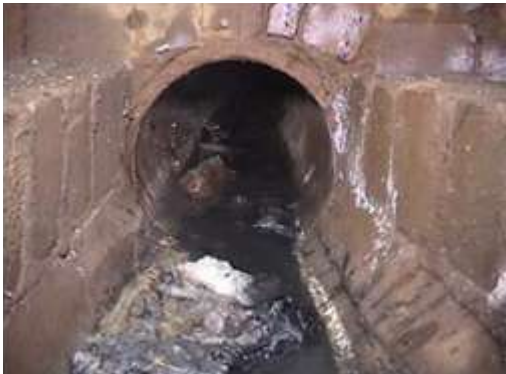
Defect 5

Condition: ☐ Sound ☐ Cracked ☐ Root Intrusion ☐ Deteriorated ☐ Leaks ☒ **Debris**

Debris in channel.

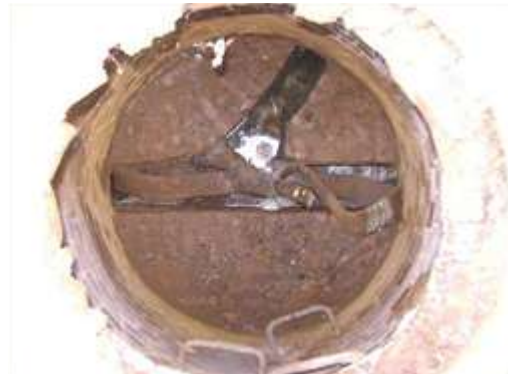
Defect 1

Comments **FIRE HOSE IN MANHOLE IS BLOCKING THE CHANNEL. WE MOVED IT TO THE BENCH FOR THE INSPECTION BUT IT MAY WORK IT'S WAY BACK IN THE CHANNEL.**

Fire Hose in Channel

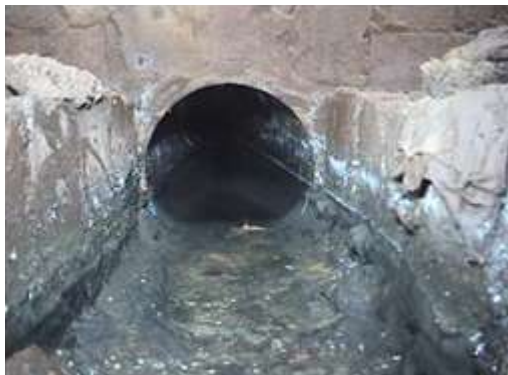
Defect 6

Condition: ☐ Sound ☐ Cracked ☐ Root Intrusion ☐ Deteriorated ☐ Leaks ☒ **Debris**

Debris on bench.

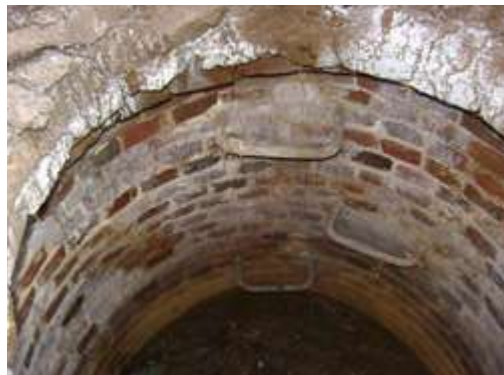
Defect 2

Offset: **2** (in.)

Offset Frame
